Penetration of water into cracked geopolymer mortars by means of neutron radiography

Water transport into cracked fly ash geopolymer mortars were investigated, for the first time, using neutron radiography. Three samples were prepared and cracks were induced in these samples. The first sample does not contain internal waterproofing additives, the second contains Lignosulphonates based waterproofing admixture and the third sample was covered with external waterproofing slurry coat. Neutron radiography images were acquired continuously during the moisture absorption process. The results obtained showed that water absorption into first sample is the fastest. The internal waterproofing additives minimized water absorption into the second sample. The waterproofing slurry coat stopped water ingress into the third sample for 109 min, however after that time it started to absorb water from the crack region only. Water is fed to all portions of the samples from the water filled cracks. The advance of water from the cracks into the matrix of the samples follows the square root of the absorption time.

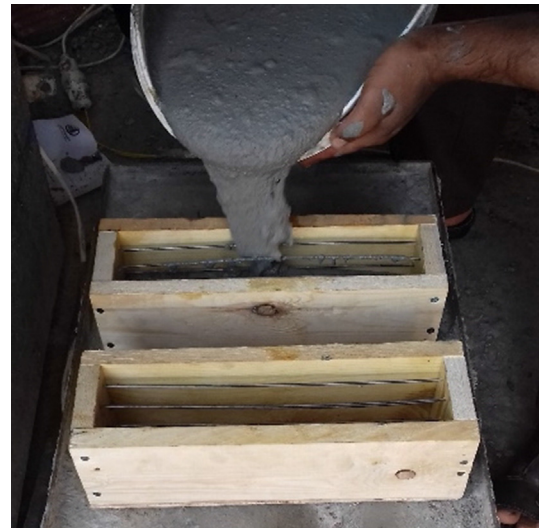
Fig. 1a. Placing of specimens.

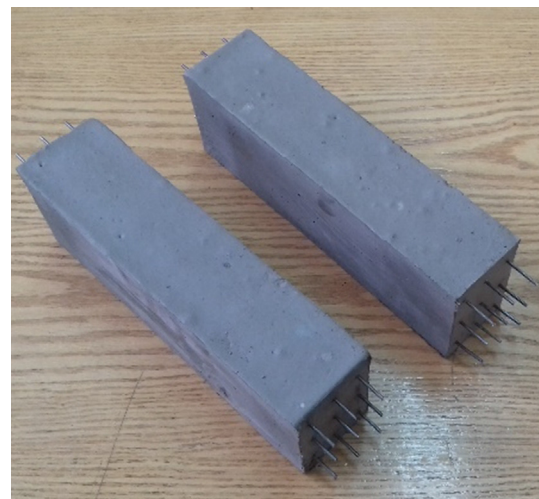
Fig. 1b. Hardened specimens.

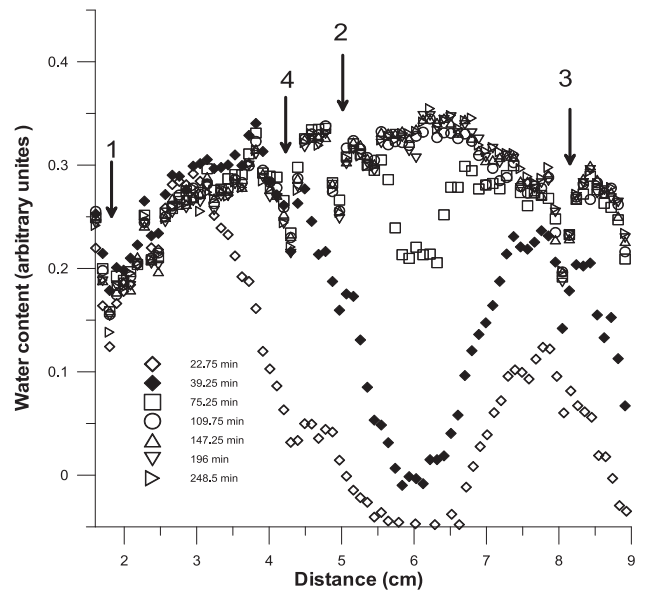
Fig. 6a. Vertical water profiles for the left side of the crack for Mix#1 sample determined at different absorption times. The left rectangle shown in Fig. 2 at absorption time, T = 249.25 min was used. Arrows number 1, 2, and 3 refer to the position of the steel bars. Arrow number 4 refers to a reference line.

Two vertical rectangular areas at the left and right sides of the crack, shown in Fig. 2 at absorption time, T = 249.25 min for the Mix#1 sample, were used to determine the vertical water profiles. The results are shown in Figs. 6a and 6b for the left and right sides of the crack, respectively. The profiles for the right side are different from those for the left side. The right profiles are more regular

than that of the left ones which confirm that structure of this sample is not homogenous. The positions of the steel bars are clearly seen from these results. Corresponding vertical water profiles for the Mix#2 sample at the left and right sides of the crack are shown Figs. 7a and 7b, respectively. In contrast to the profiles of the Mix#1 sample, the profiles for the Mix#2 sample at both sides of the crack are similar to each other. This indicates that, Mix#2 sample is more homogenous than Mix#1 sample. The vertical profiles for both Mix#1 and Mix#2 samples indicate that the left and right sides of the cracks are fed water from both the cracks and the water container.

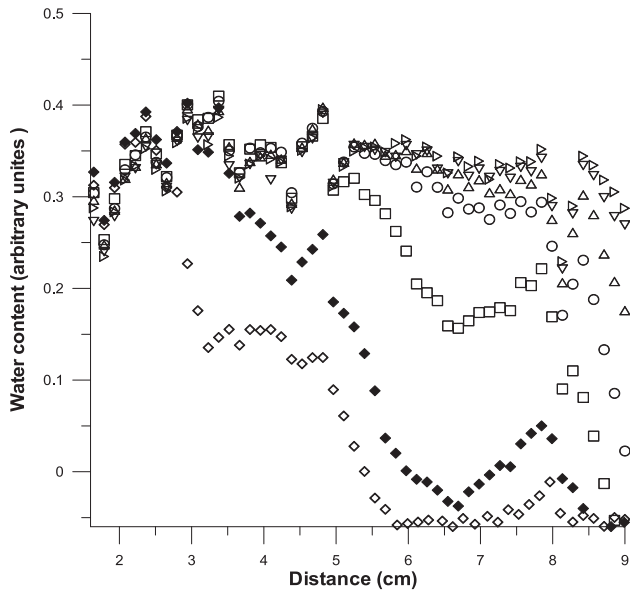
Fig. 6b. Vertical water profiles for the right side of the crack for Mix#1 sample determined at the same absorption times of Fig. 6a. The right rectangle shown in Fig. 2a at the absorption time, $T = 249.25$ min was used.

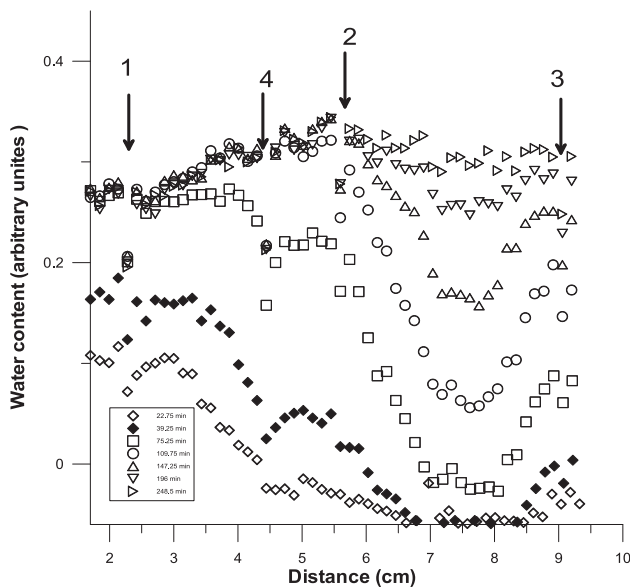
Fig. 7a. Vertical water profiles for the left side of the crack for Mix#2 sample determined at different absorption times. Arrows number 1, 2, and 3 refer to the position of the steel bars. Arrow number 4 refers to a reference line.
