## RESULTS OF EXPERIMENTAL GEORADAR SURVEYS OF RAILWAY SECTIONS

**ABSTRACT:** The aim of the study is to evaluate the effectiveness of using georadar sounding as a high-speed method for monitoring the condition of subsurface layers of railway infrastructure facilities and identifying zones of abnormal structure in the embankment and underlying soil, which could worsen the bearing properties of the soil at the base of the railway track, and develop specific measures to eliminate soil defects. The methodology of the study involved conducting georadar surveys using Loza geophysical complex and antennas with 100 cm, lateral steps of 50 cm and 20 cm, and a depth of sounding up to 256 ns to profile the embankments of new and old railway tracks and transverse georadar profiles through problem areas. Abnormal violations of the railway embankment structure were detected through georadar survey, revealing local heterogeneities due to insufficient and uneven compaction, while the main part of the embankment and the bedrock at its base remain unaffected. The practical significance of this research is that it provides important information about the structural integrity of railway embankments,

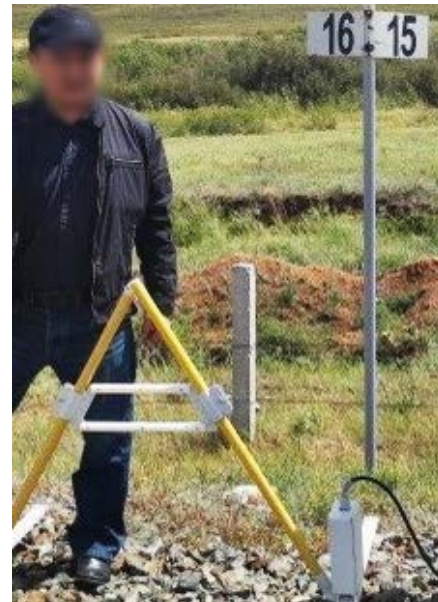
Fig.1 The first measurement along the railway

edge of the railway track. The profile length is 2 kilometers. There were objects along the railway track:

1. Double pipes for animals to cross paths.
2. Kilometer reserve (additional rail along the tracks).
3. Interval control sensor.
4. Integrated control system (ICS) (Fig. 1).

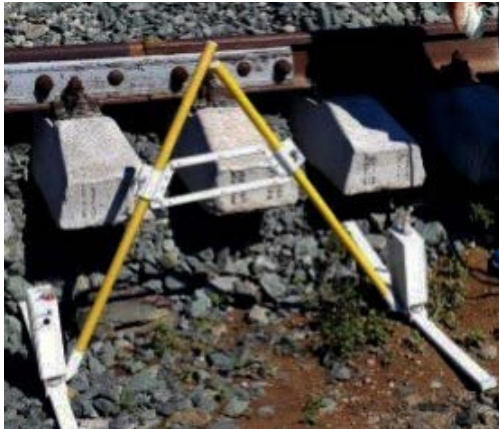
Fig.2 The second dimension along the railway under construction

2nd dimension "B", "C". A section of the railway track is under construction with a length of 2 km. The survey was carried out in one direction along the edge of the railway track. "B" – measurements of the track with rails. "B" – measurements of the track without rails, along the embankment. The profile length is 2 kilometres. There were objects along the railway track:

1. Double pipes for animals to cross paths.
2. Kilometre reserve (additional rail along the tracks).
4. Interval control sensor.
5. Integrated control system (Fig. 2) [16,17].

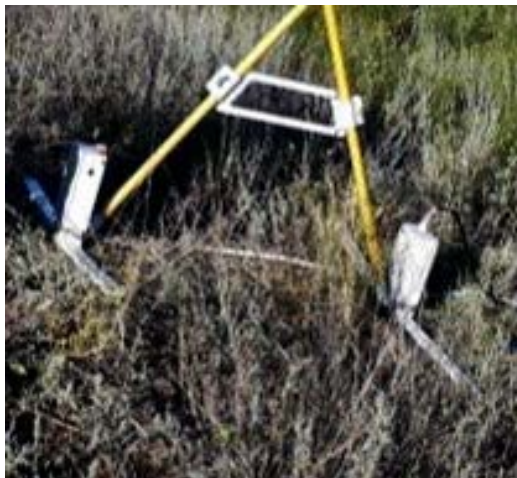
Fig.3 The third transverse dimension of the railway

3rd dimension "R". Transverse measurements in three different problem areas to clarify the identified causes of problems in the underlying layers (Fig. 3):

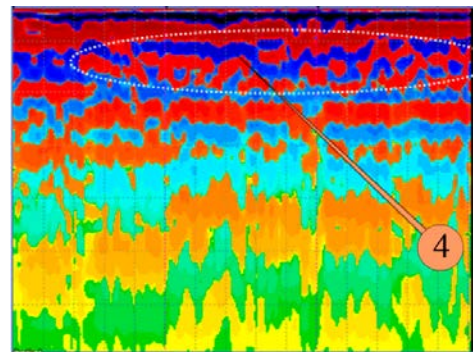
Fig.16 The second measurement of site "B" by georadar – (750-900 metres on the opposite side)

900m, heterogeneity and stratification of structural horizons were found at 770-900m in the embankment array (4). At depths of 3-5 metres, a normal, undisturbed structure of the bedrock is recorded (Fig. 16). At the site "C-1" 0-250 metres, starting from the 150-metre mark, elements of heterogeneity and stratification of the structural horizons in the embankment array (4). The nature and structure of the radio pattern of anomalies indicate uneven compaction of the soil layers. At depths of 3-5 metres, a normal structure of the bedrock is recorded (Fig.17).
